Klondyke Tailings

Water Quality Assurance Revolving Fund ([WQARF](#)) Site

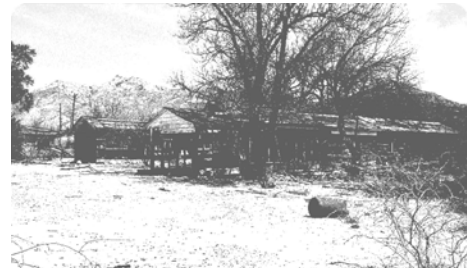
Old Flotation Mill Buildings at Klondyke Tailings Site

1870-1950: From the 1870s through the 1950s, lead, zinc, copper, silver, and gold mining was conducted in the Klondyke area of the Aravaipa Mining District. In 1948, the Athletic Mining Company constructed a flotation mill next to Aravaipa Creek that operated until about 1958 and generated, in part, the tailings at the Site. Other possible sources are being investigated.

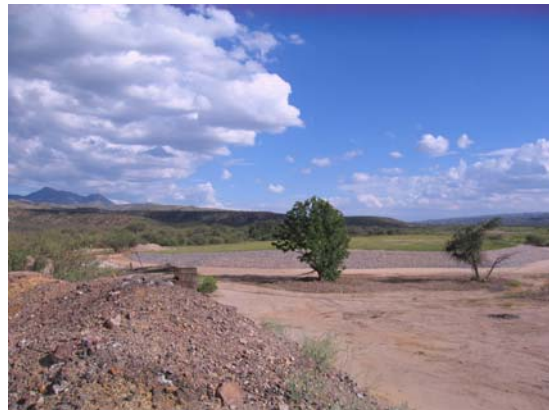
Completed Erosion Protection and Clean Cap on Upstream Tailings Pile

In June, ADEQ and their contractors completed the consolidation, capping with a two-foot clean soil cover and installation of erosion protection on the upstream pile. During fiscal year 2008, ADEQ spent approximately \$3,000,000 on construction of the erosion protection and cap for the upstream tailings pile. ADEQ received a draft of the RI Report from the contractor.
