## Broadway-Pantano

### Water Quality Assurance Revolving Fund ([WQARF](#)) Site

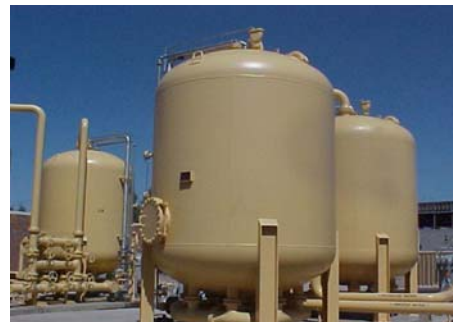
**The Broadway-Pantano Western Groundwater Containment System**

**2003:** In the spring, ADEQ and the COT completed the installation of the WCS at the western edge of the plume. The WCS consisted of two [extraction wells](#), GAC treatment system, and two [injection wells](#). The total construction costs for this ERA were approximately \$3 million and were funded by ADEQ. On March 24, 2003, the WCS began full operation. Analytical results showed that the treatment system was removing the PCE to non-detectable levels.

When the WCS was initially brought on line, the extraction rate was 1100 gallons per minute (gpm). However, in the summer, the injection capacities in the R-090A and R-091A injection wells decreased because of plugging so the WCS extraction rate was reduced to 800 gpm. Subsequently, both injection wells were rehabilitated/redeveloped and injection-specific capacities improved but not to original levels. Back flushing of the injection wells would need to be performed regularly to maintain performance.

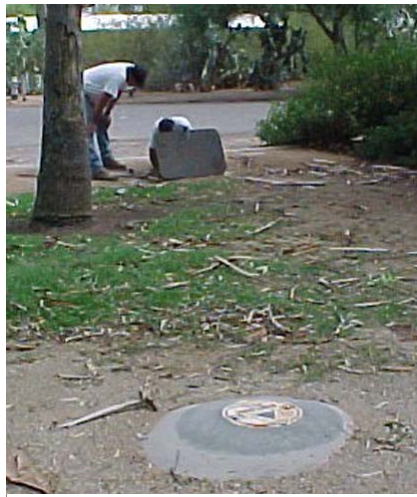
**Monitor Well on Residential Street Right-of-Way**
